# 9133 Fan Repair

## 9133 Top Panel Removal

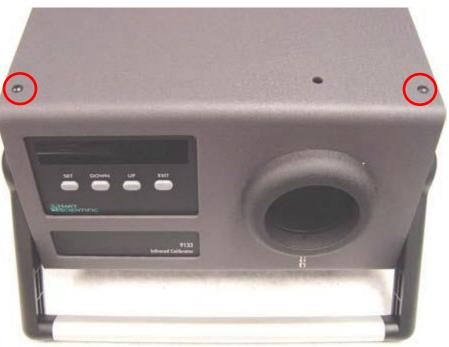
Remove the 6 screws holding the top panel in place. 2 are underneath the front, 2 are on top, and 2 are in the back.

Remove the top panel by lifting up on the back part of the top panel.

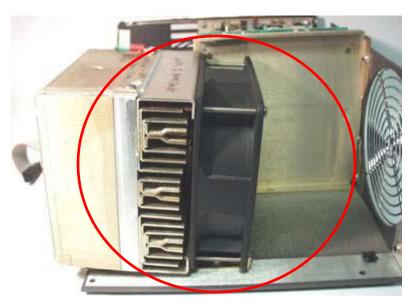
With the top panel removed, disconnect the display cable.

Note the orientation of the cable being removed.

2) The fan is located behind the IR target and is attached to the heat sink.

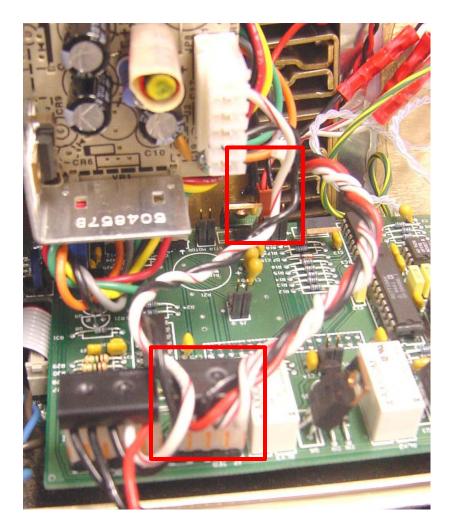
1

Remove the three IR target cables from the controller board.

One is the fan cable, one is the TE mod cable, and the third is the sensor cable.

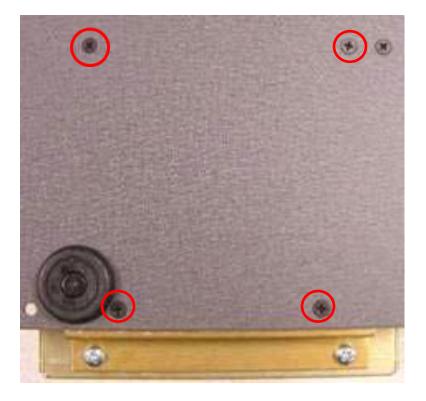
3 Turn the 9133 over and remove the 4 screws holding the block in place.

The block should now be free to be removed and worked on.
