How to check and fix PG AutoRotate system

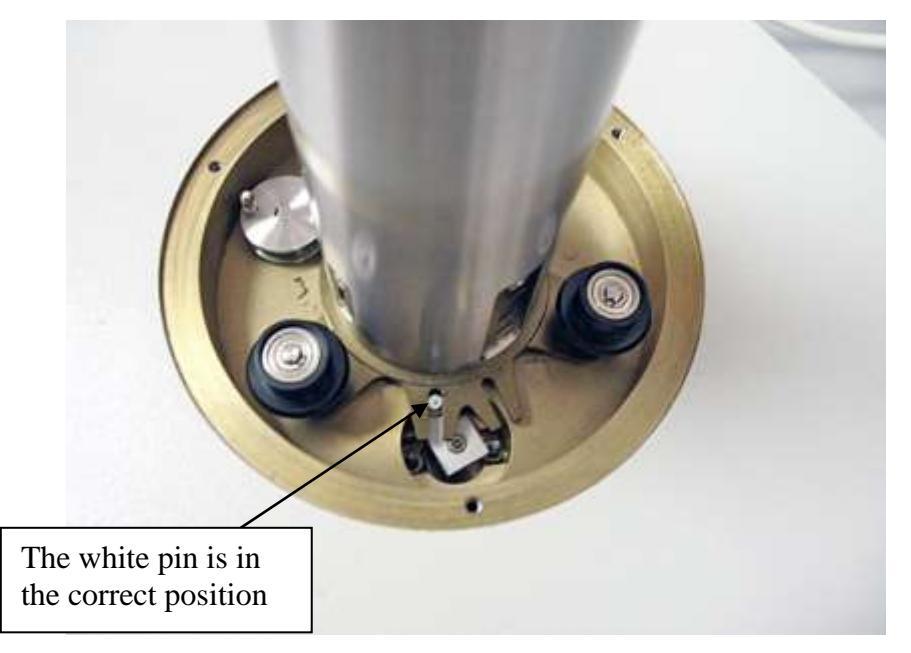
Figure 1: In a normal AutoRotate system, the white pin should be about 2 mm from the end of the slot when idle (solenoid is not engaged).

- 1. Do you hear a click when the display first shows "ACCELERATING" on the top line? This is the engagement solenoid or motor turning on. If you do not hear a click, then you do not need to continue to step 2. The engagement solenoid may need to be replaced. Contact DHI or your local DHI representative.
- 2. Turn off the PG. Then remove the mass bell. Near the mounting post, there is a circular metal plate on the PG that is held in place by three screws. The three outer screws holding the plate to the base can be removed, and the plate can then be taken off the base. If the PG's hardware is in the correct position, it should look like figure 1 below. There is a white pin in a metal slot. The pin should be about 2mm from the end of the slot as shown.

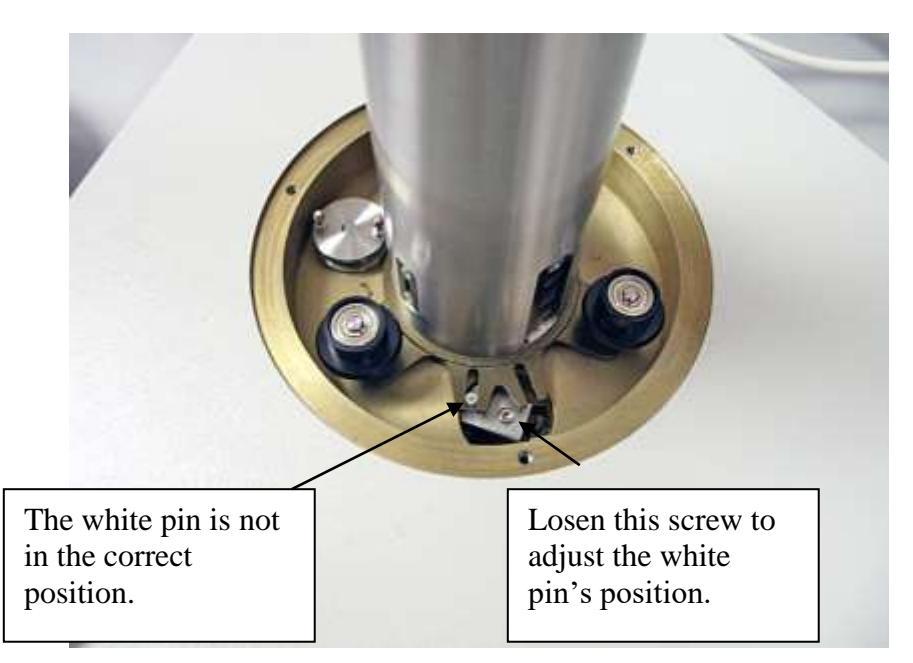
Figure 2: The white pin is in the wrong position. The pin's position can be adjusted if the metal screw is loosened. Tighten the metal screw when the pin is in a good position.

In some PG's, the white pin will be moved to the wrong position, as shown in Figure 2. If this is the case, loosen the metal screw shown in Figure 2. Adjust the pin position so that it is approximately 2 mm from the end of the slot. A small allen wrench can be put between the pin and the slot during tightening to ensure that the pin will remain approximately 2mm from the end of the slot Retighten the metal screw to fix the white pin in its new locataion.

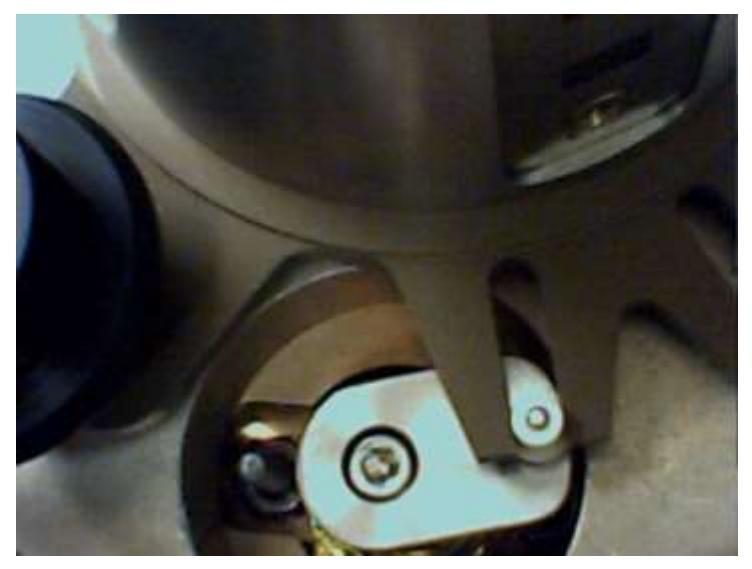
Figure 3: The solenoid is engaged and the white pin is in the correct position.

Figure 3 shows the correct position when the solenoid is in the engaged position. You can manually rotate the assembly to check that the white pin does not go out of the slot when the solenoid is engaged.

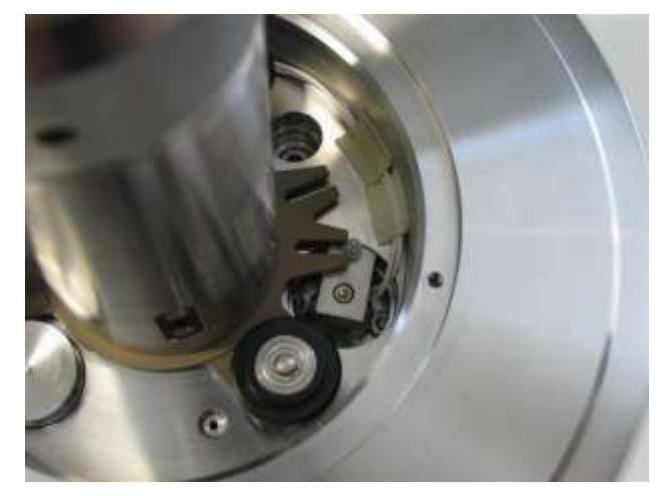
Figure 4: The solenoid is engaged and the white pin is in the wrong position
